Inspection Report
Minerals Regulatory Program
Report Date: March 28, 2005

Mine Name: T&M Holdings

Permit number: Unpermitted,
M/035/023

M/035/023, Decorative Landscaping

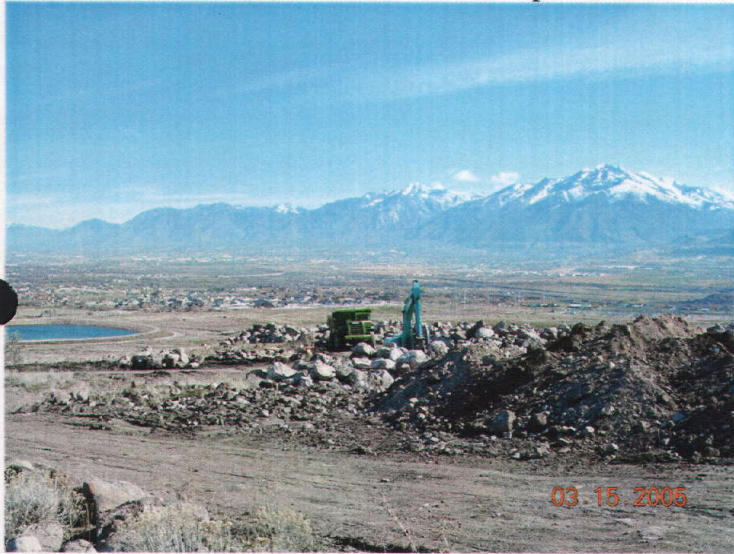
Photo 1. A dump truck and one of two trackhoes that were at the site.

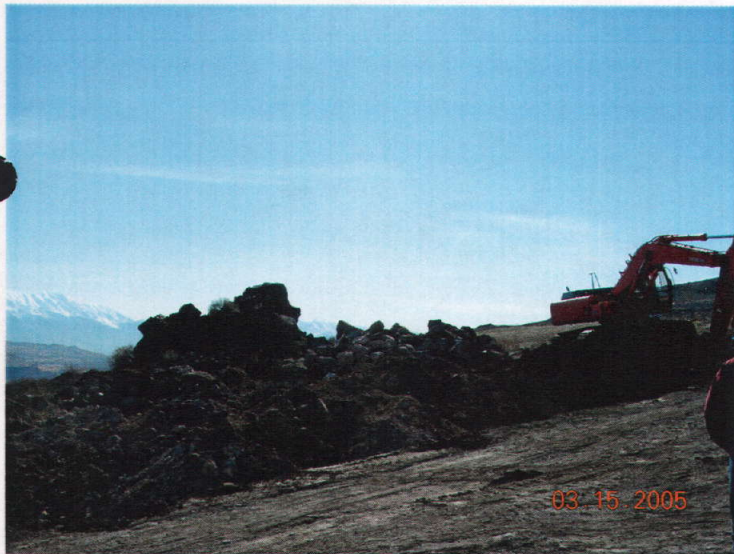
It appears the operator has primarily been taking rock from the surface, but during the inspection, one of the trackhoes was digging rock from a hole about 5-10 feet deep next to a rock outcrop (Photo 2). Other views of the disturbed area are in Photos 1, 3, and 4.

Photo 2. On the left side of the picture is a rock outcrop. The trackhoe had dug a hole about 5-10 feet deep.

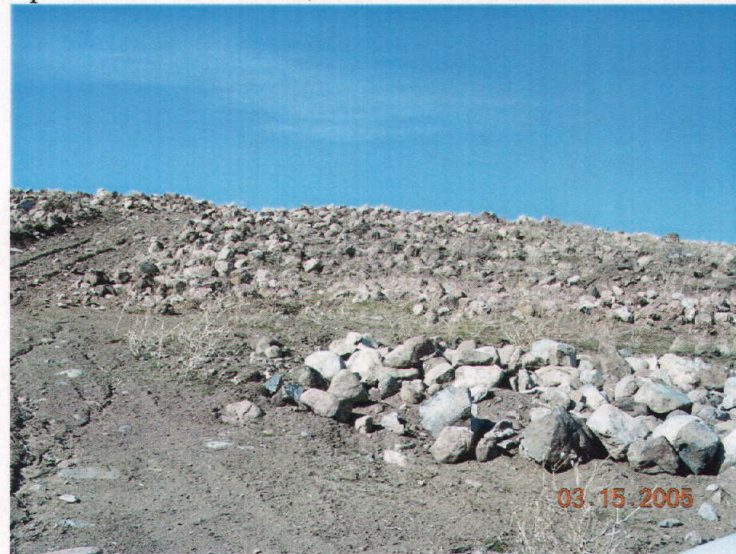
Photo 3. An overview of part of the upper portion of the site.

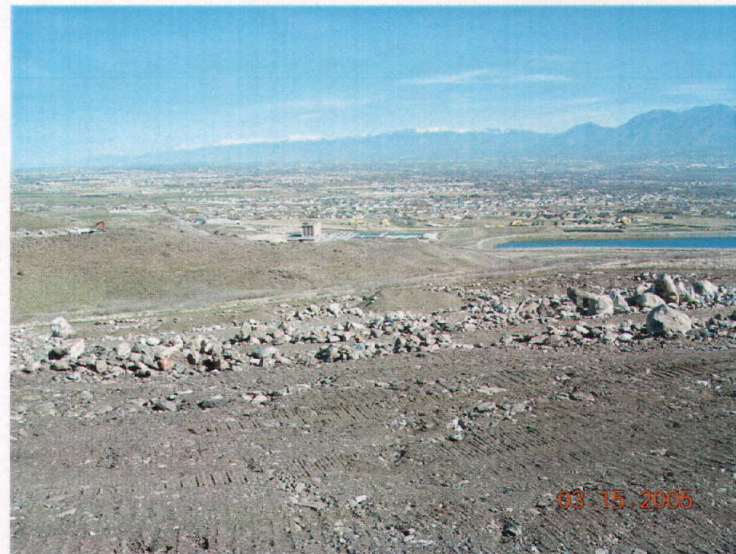
Photo 4. Another view of the upper portion of the site.
